# An Investigation of the Therac-25 Accidents

Nancy G. Leveson, University of Washington

Clark S. Turner, University of California, Irvine

**A thorough account of the Therac-25 medical electron accelerator accidents reveals previously unknown details and suggests ways to reduce risk in the future.**

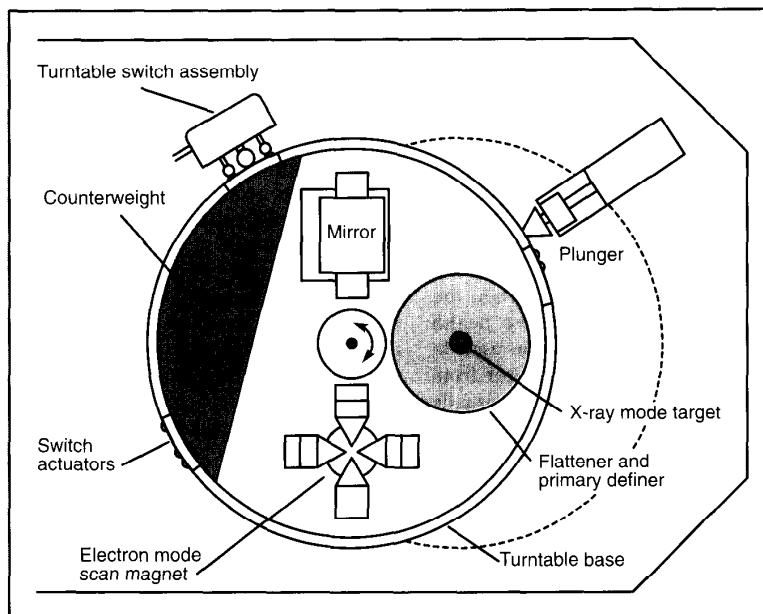
Figure B. Upper turntable assembly.

*Manufacturer response.* AECL could not reproduce the malfunction that had occurred, but suspected a transient failure in the microswitch used to determine turntable position. During the investigation of the accident, AECL hardwired the error conditions they assumed were necessary for the malfunction and, as a result, found some design weaknesses and potential mechanical problems involving the turntable positioning.

crosswitch codes (which could be caused by a single open-circuit fault on the switch lines) could produce an ambiguous position message for the computer.

hazard of dual-mode machines: If the turntable is in the wrong position, the beam flattener will not be in place.

No accelerator beam is expected in the field-light position. A stainless steel mirror is placed in the beam path and a light simulates the beam. This lets the operator see precisely where the beam will strike the patient and make necessary adjustments before treatment starts. There is no ion chamber in place at this turntable position, since no beam is expected.

cate turntable position that tolerated a 1-bit error: The code would still unambiguously reveal correct position with any one microswitch failure.

The modifications recommended in the Symonds report included redesigning the microswitch and changing the way the computer handled malfunction conditions. In particular, treatment was to be terminated in the event of a dose-rate malfunction, giving a treatment "suspend." This would have removed the option to proceed simply by pressing the "P" key. The report also made recommendations regarding collimator test procedures and message and command formats. A November 8, 1985 letter signed by Ernest Létourneau, M.D., director of the CRPB, asked that AECL make changes to the Therac-25 based on the Symonds report "to be in compliance with the RED Act."

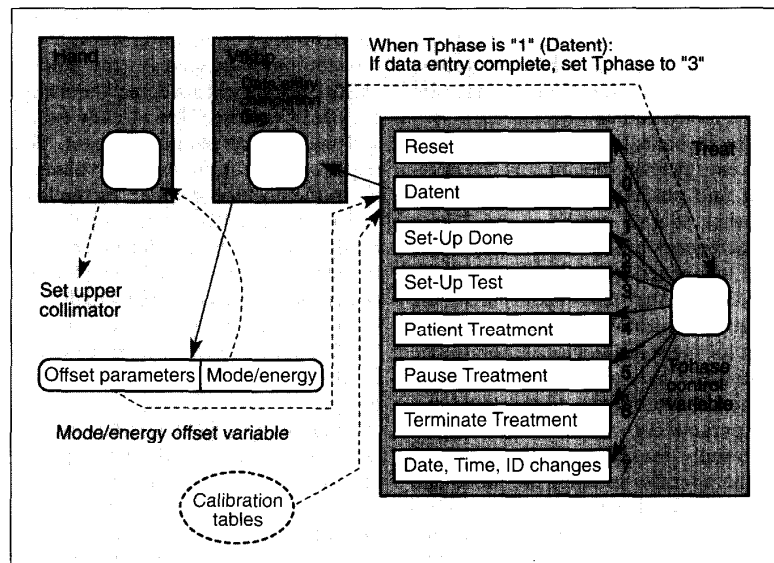
Figure 2. Tasks and subroutines in the code blamed for the Tyler accidents.

As described in the sidebar on Therac-25 software development and design, the treatment monitor task (Treat) controls the various phases of treatment by executing its eight subroutines (see Figure 2). The treatment phase indicator variable (Tphase) is used to determine which subroutine should be executed. Following the execution of a particular subroutine, Treat reschedules itself.

One of Treat's subroutines, called Datent (data entry), communicates with the keyboard handler task (a task that runs concurrently with Treat) via a

shared variable (Data-entry completion flag) to determine whether the prescription data has been entered. The keyboard handler recognizes the completion of data entry and changes the Data-entry completion variable to denote this. Once the Data-entry completion variable is set, the Datent subroutine detects the variable's change in status and changes the value of Tphase from 1 (Data Entry) to 3 (Set-Up Test). In this case, the Datent subroutine exits back to the Treat subroutine, which will reschedule itself and begin execution of the Set-Up Test subroutine. If the Data-entry completion variable has not been set, Datent leaves the value of Tphase unchanged and exits back to Treat's main line. Treat will then reschedule itself, essentially rescheduling the Datent subroutine.

Upon exit from the Magnet subroutine, the data-entry subroutine (Datent) checks the data-entry completion variable. If it indicates that data entry is complete, Datent sets Tphase to 3 and Datent is not entered again. If it is not set, Datent leaves Tphase unchanged, which means it will eventually be re-scheduled. But the data-entry completion variable only indicates that the cursor has been down to the command line, not that it is still there. A potential race condition is set up. To fix this, AECL introduced another shared variable controlled by the keyboard handler task that indicates the cursor is not positioned on the command line. If this variable is set, then prescription entry is still in progress and the value of Tphase is left unchanged.

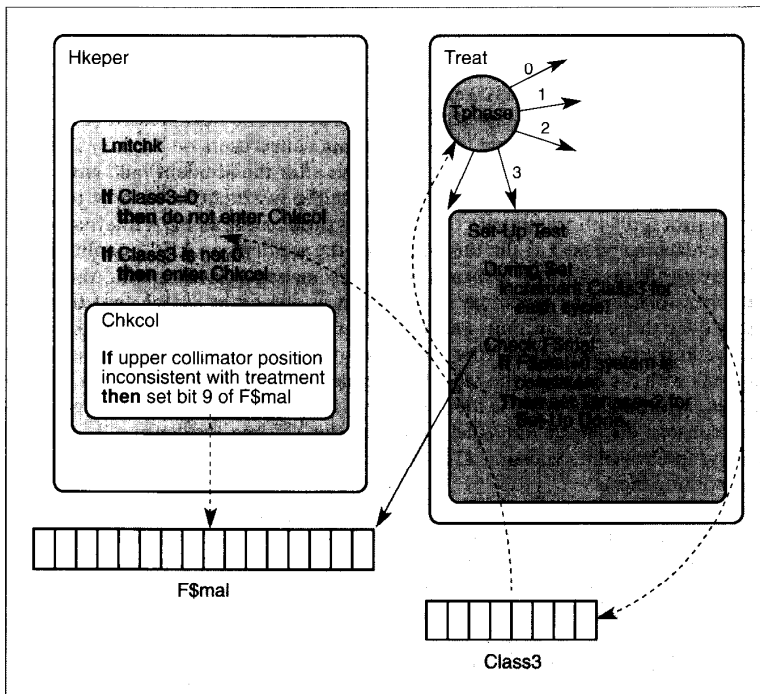
Figure 4. Yakima software flaw.

The second Yakima accident was again attributed to a type of race condition in the software — this one allowed the device to be activated in an error setting (a "failure" of a software interlock). The Tyler accidents were related to prob-

lems in the data-entry routines that allowed the code to proceed to Set-Up Test before the full prescription had been entered and acted upon. The Yakima accident involves problems encountered later in the logic after the treatment monitor Treat reaches Set-Up Test.
